# Manhole Inspection Summary

Manhole # S33AA\_006MH

Insp Date: **8/31/09 11:16 AM**

**Location** Address: **706 CATHEDRAL ST**

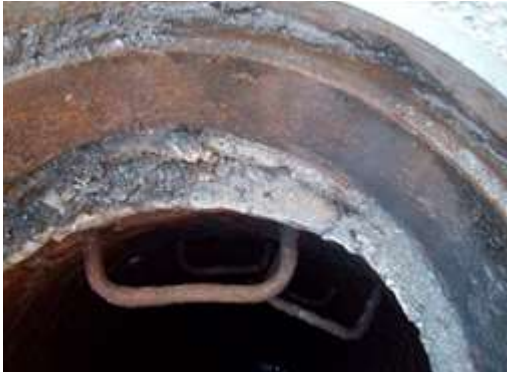
Defect 2

Offset: **2** (in.)

FRAME OFFSET

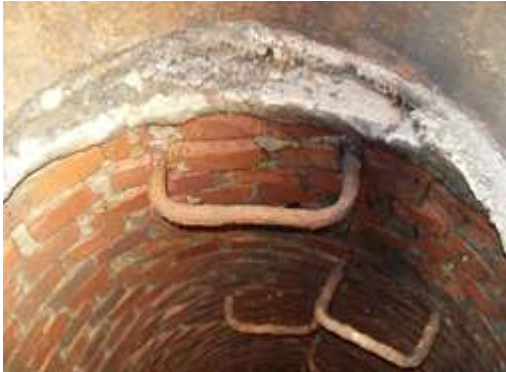
Defect 1

Count: **17** Missing: **0** ☒ **Corroded**

CORROED STEPS

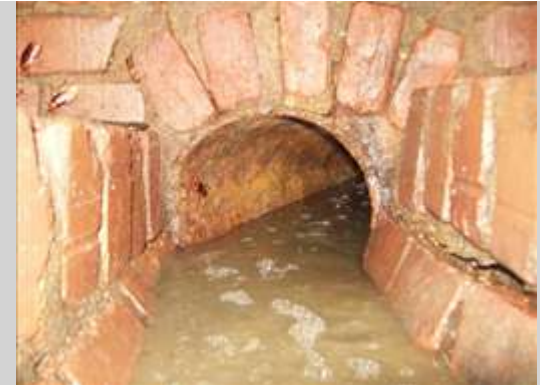
12 O'Clock Outflow

8 in. Circular Gravity Sewer  
Pipe Out @ 12 O'Clock

Pipe Height: (in.) Direct  
Pipe Material: **Clay** ☐ Pipe Lined  
Invert Depth: **25.78** (ft.) Flow Characteristics: **Slow**  
Deposits: ☒ None ☐ Mud ☐ Sludge ☐ Debris ☐ Grease  
Silt Depth: (in.) Deposits Extent:  
Infiltration: **None** Pipe Seal Cond: **Sound**

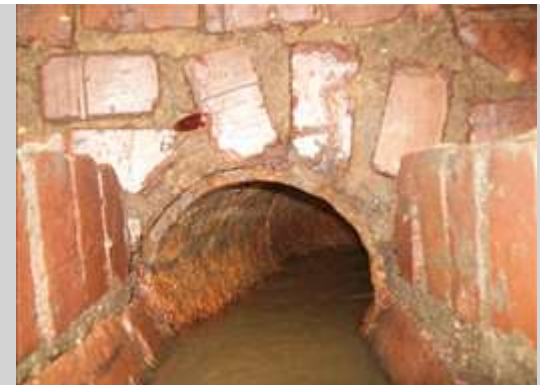
6 O'Clock Inflow

8 in. Circular Gravity Sewer  
Pipe In @ 6 O'Clock

Pipe Height: (in.) Direct  
Pipe Material: **Clay** ☐ Pipe Lined  
Invert Depth: **25.52** (ft.) Flow Characteristics: **Slow**  
Deposits: ☒ None ☐ Mud ☐ Sludge ☐ Debris ☐ Grease  
Silt Depth: (in.) Deposits Extent:  
Infiltration: **None** Pipe Seal Cond: **Sound**

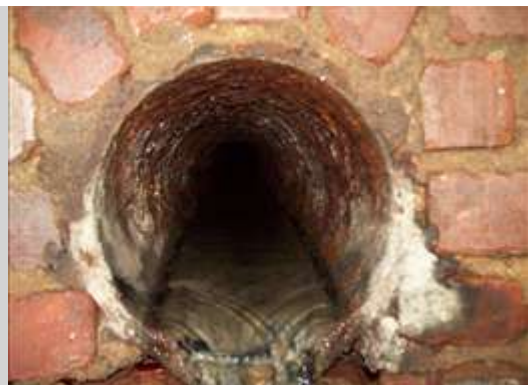
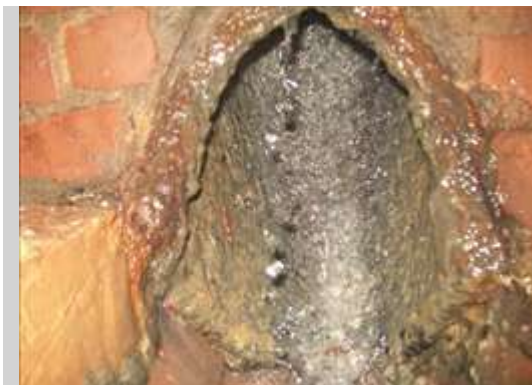
9 O'Clock Inflow

Pipe In @ 9 O'Clock

Drop In @ 9 O'Clock

Drop: **Inside** **Direct**

Drop Condition: **Open**
